3G FOOTBALL PITCH - MAJOR REPAIRS AND REFURBISHMENT

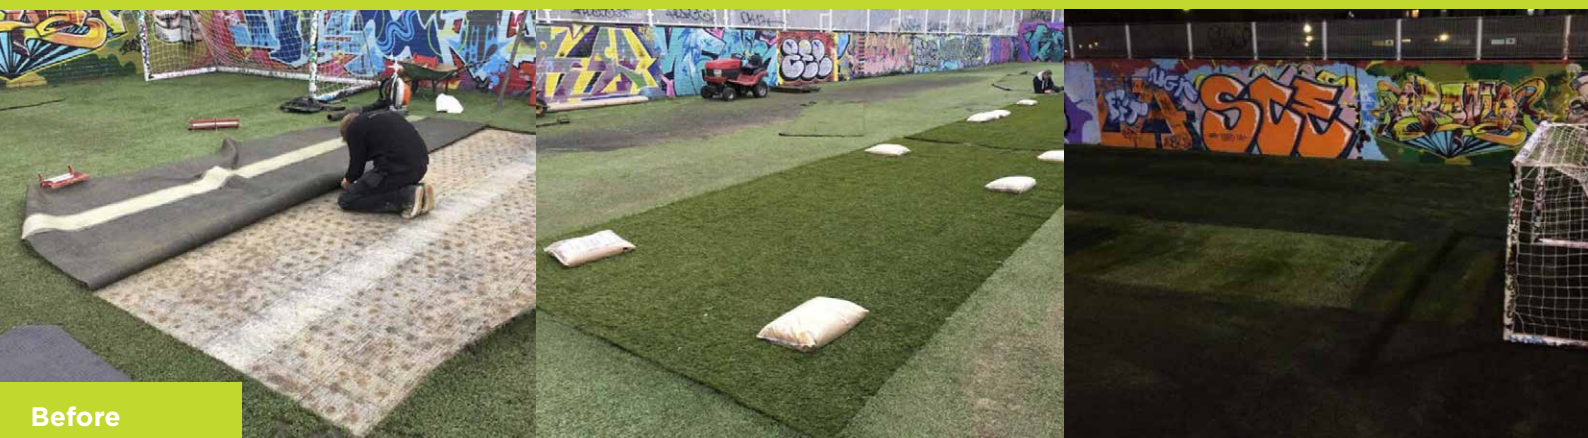
Before

The issue with a lot of community surfaces based within inner city estates is that they get a huge amount of use. At Broadway Market, the centre of the pitch was worn out with areas through to the backing of the grass and subsequent damage to the base. The grass pile was sitting completely flat with the rubber and sand compacted right into the base of the pile.

With very limited access, less than 1m concrete tunnel, the brief was to repair shock pad damage and replace the damaged areas of 3G grass with the nearest possible match. Rejuvenate the whole surface so that it was safe and playable for the community.
