REPAIRING A WATER BASES HOCKEY PITCH SURFACE

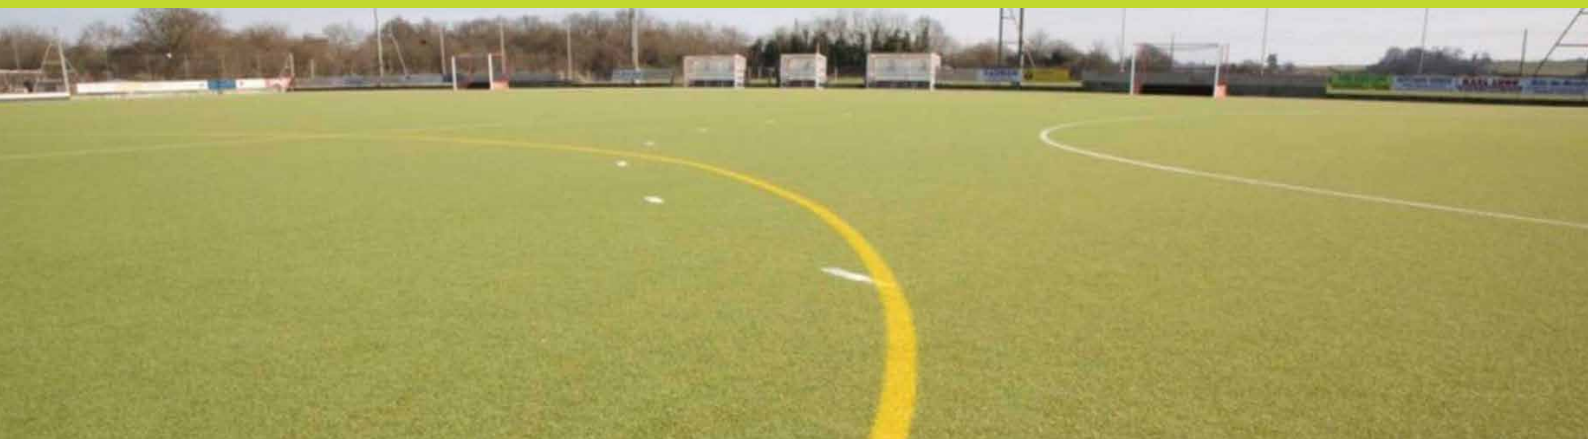
The pitch is in excellent condition, however 2 seams on the near side D are failing. The first team didn't want any patches putting in - a near impossible brief. As Artificial Grass Cambridge have a long-standing relationship with Harleston Magpies they were the only maintenance contractors asked to do the repairs.

"The surface is fastened in a channel system around the edges. Where the seam had failed the surface had frayed, we were able to release the surface from its channel allowing a little movement. The grass was then stretched over the existing frayed area which was then cut out and the area re-taped and glued and weighted." - Rob Norton, Artificial Grass
