AMAZING TRANSFORMATION OF AN UNUSED ASPHALT AREA

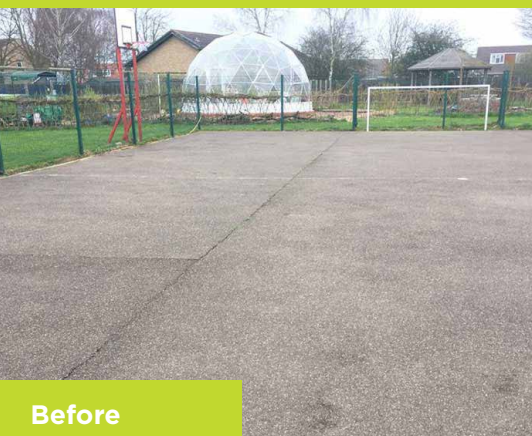
Gunthorpe Primary School, Peterborough had an asphalt area measuring approximately 23m x 16m with internal curbing and recessed goals laid onto mud. A 1.2m fence surrounded the area. Before works: The area was not draining, often being covered in sitting water. It was unsafe for the children and ultimately was unused.

- The curbs were extended to just outside the fencing.
- Extended out the surface using concrete to incorporate the recessed goals.
- Drainage holes were drilled at 600mm centres into the entire surface, adding pea gravel to the holes.
- Fencing was extended on two sides to give an extra 2m of soft fencing to protect the school's greenhouses and neighbouring homes. This was an option that no other contractor was able to give, a cost effective alternative, it allowed the budget to be put towards the surface and shockpad.
- The entire surface was covered in Playrite® Matchpad 1500 shockpad to help give even ball bounce and create a safe surface for the children.

- TigerTurf® EvoPro was installed and lines cut in for 5-A-Side football & four basketball keys. All seams were taped and glued using Envirostik® Sports fix glue.
- Garside 2EW infill was then added and brushed ready for use.
- New 5-A-Side goals from Stadia Sport completed the area.

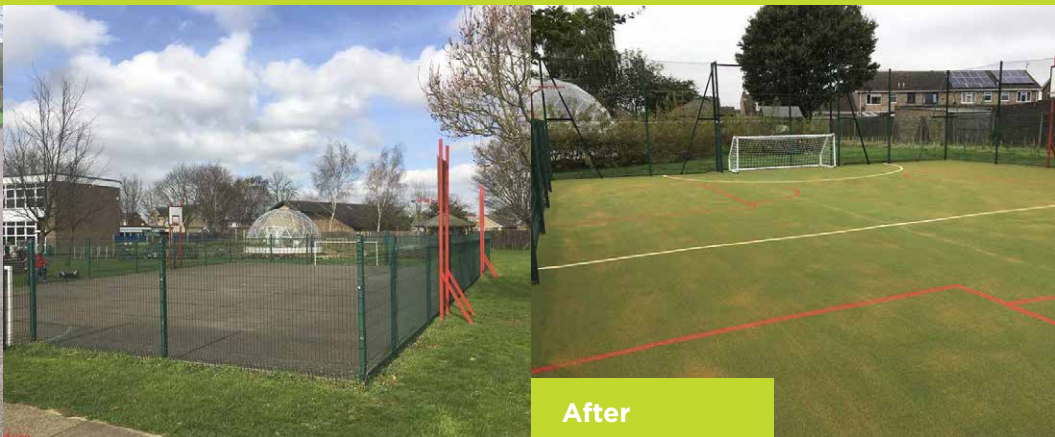
After

Within a week, the pitch is now used daily for PE lessons and once a week for external 5-A-Side football training creating a revenue stream and a facility for the local community.
